NRL Report 8230

**Stress-Corrosion Cracking Characterization  
of High-Strength Steels—  
Base Metals and Weldments**

C. T. FUJII, F. W. FRASER, and E. A. METZBOWER

May 12, 1978

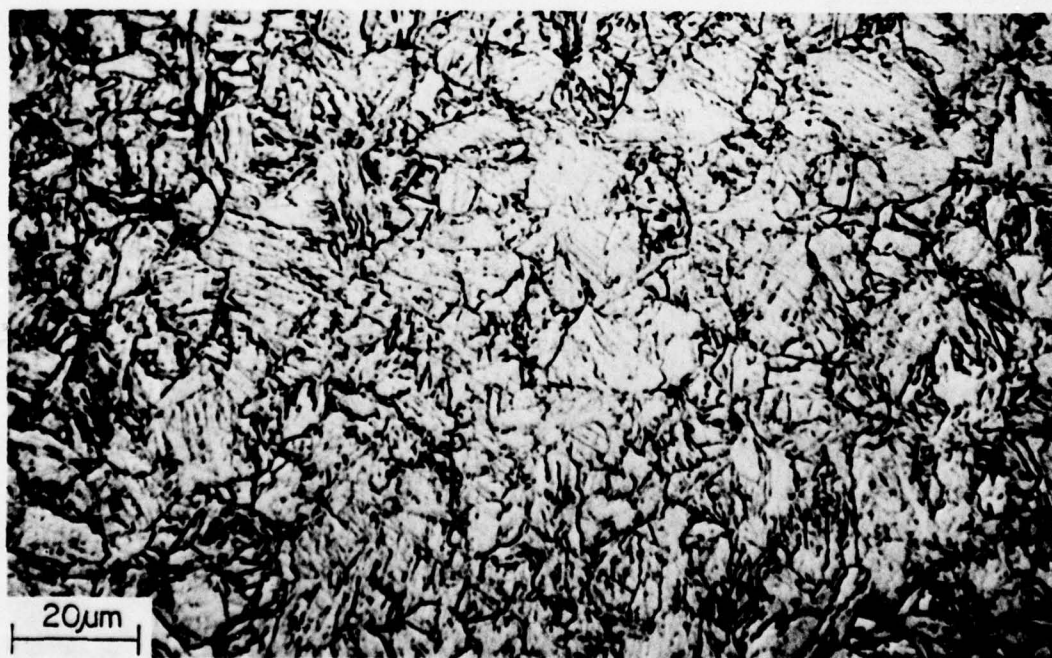
The microstructure was composed of tempered martensite of a relatively uniform grain size (Fig. 16). Microcracking was found only in the form of short secondary cracks at the fracture edge. No extensive secondary cracking was seen at the fatigue/SCC interface.

Fig. 16 — Code-B specimen: tempered martensite of uniform grain size

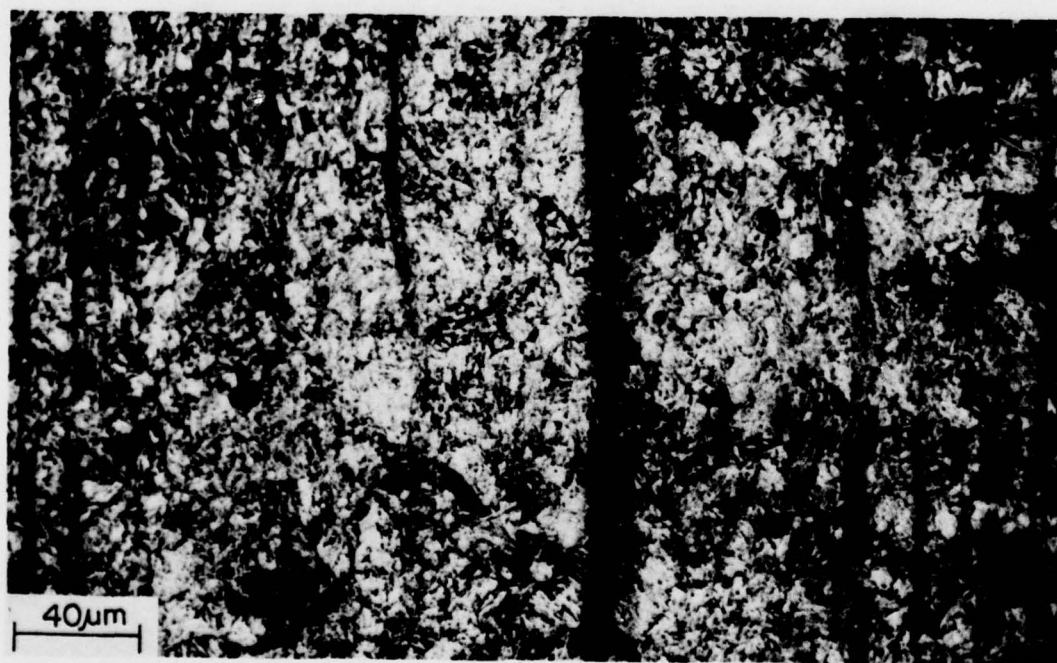
Fig. 21 — Code-C specimen: irregular banding seen in the transverse cross section

Extensive secondary cracking had taken place along the fatigue/SCC interface (Fig. 19). In general, secondary cracks found on the fracture surfaces of the specimens analyzed propagated transverse to the direction of primary crack propagation. In the code-C specimen however numerous short secondary cracks were found running parallel to the direction of the primary crack (Fig. 20). A polished and etched, transverse cross section of this specimen showed heavy, irregular banding (Fig. 21). A hardness value of 37 Rc was found in the dark etched bands, and a value of 31 Rc was found in the matrix. The longitudinal secondary cracks seen on the fracture surface are probably associated with the banding. Similar transverse cross sections of codes A and H showed very fine uniform banding with no significant variations in hardness between the darker etched bands and the lighter etched matrices.

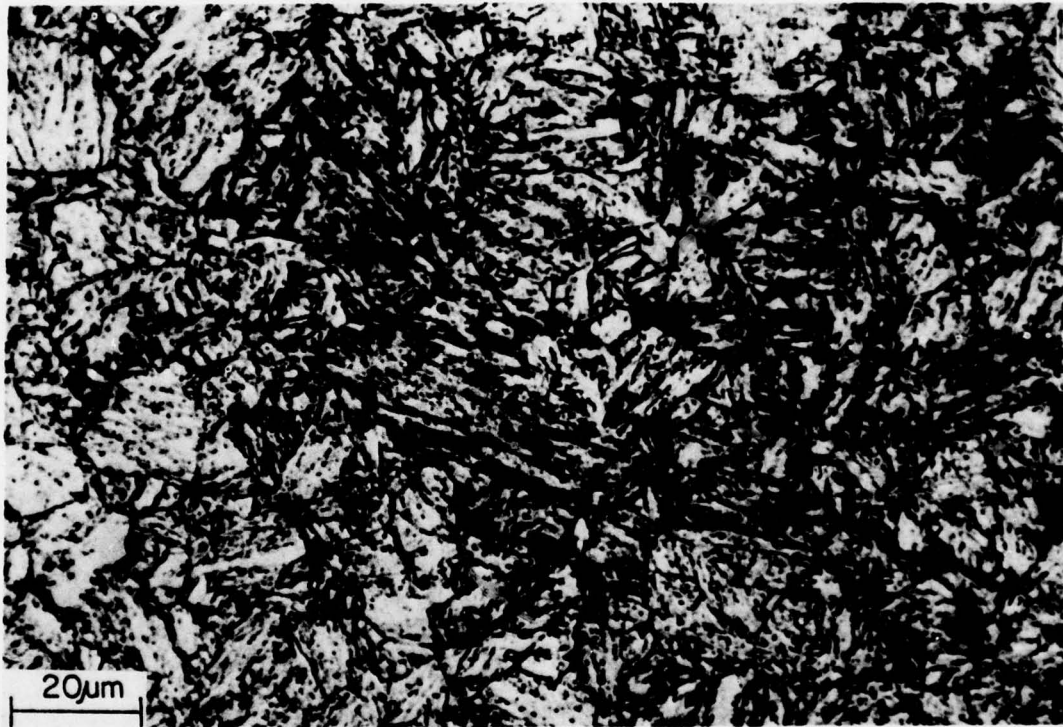
The microstructure was composed of tempered martensite (Fig. 27) slightly coarser in appearance and of a less uniform grain size than that seen in code C (Fig. 22). No evidence of spheroidization was found.

Fig. 27 — Code-H specimen: tempered martensite of a slightly coarser structure and a less uniform grain size as compared to that of the Code-C specimen (Fig. 22)

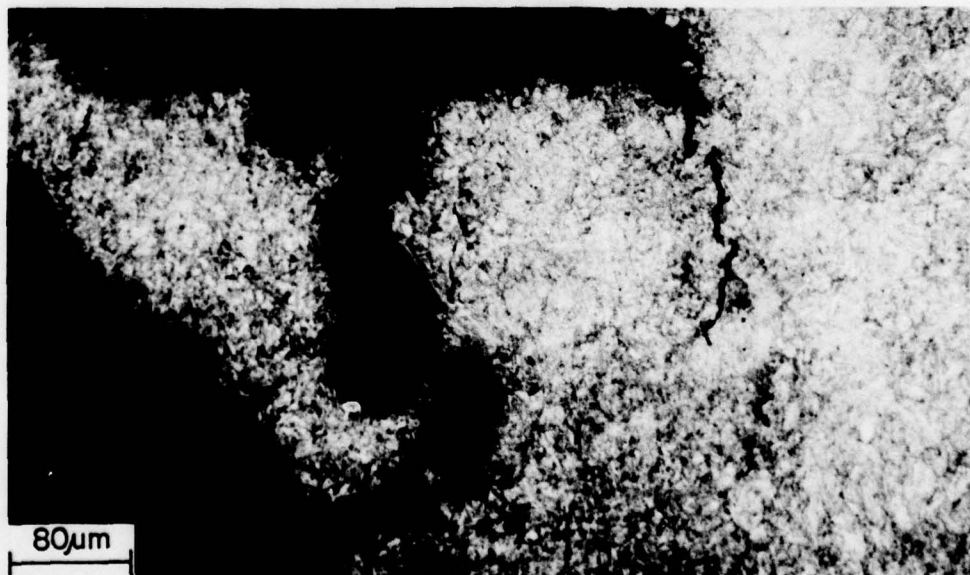
Extensive microcracking had occurred at the fracture edge and within the specimen interior (Fig. 53). The microcracks were discontinuous and in some instances could be identified as grain-boundary cracks coinciding with the carbide chains (Fig. 54).

Fig. 53 — Code-G specimen: microcracking at the fracture edge and within the interior of the specimen

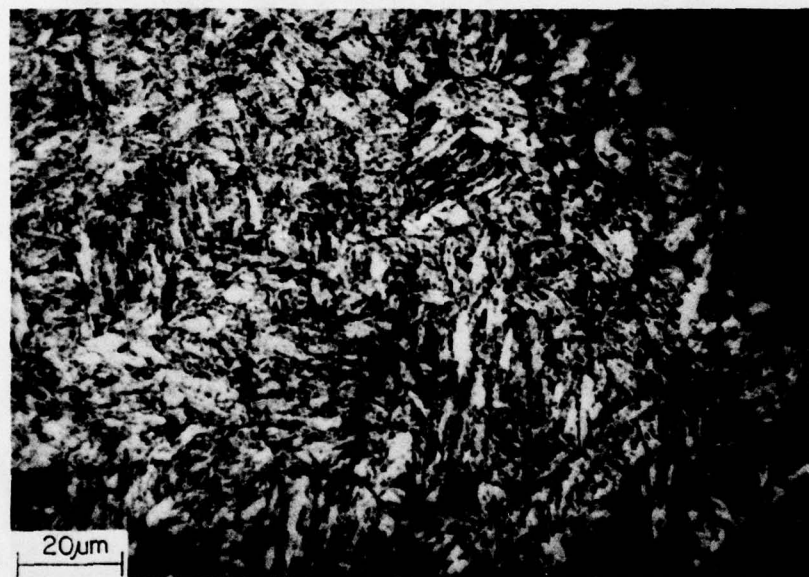
Fig. 54 — Code-G specimen: microcracks along grain boundaries and through precipitated carbides

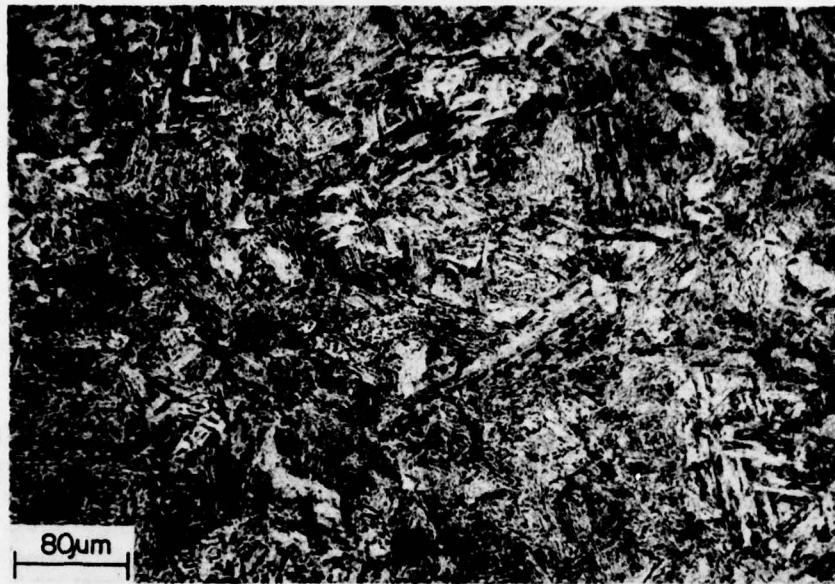
The microstructure developed upon overaging was a combination of highly tempered martensite, bainite, and retained austenite (Fig. 58). The bainitic structure is seen at higher magnification in Fig. 59. The amount of retained austenite in this specimen was approximately 8 percent.

Fig. 58 — Code-F specimen: highly tempered martensite and bainite

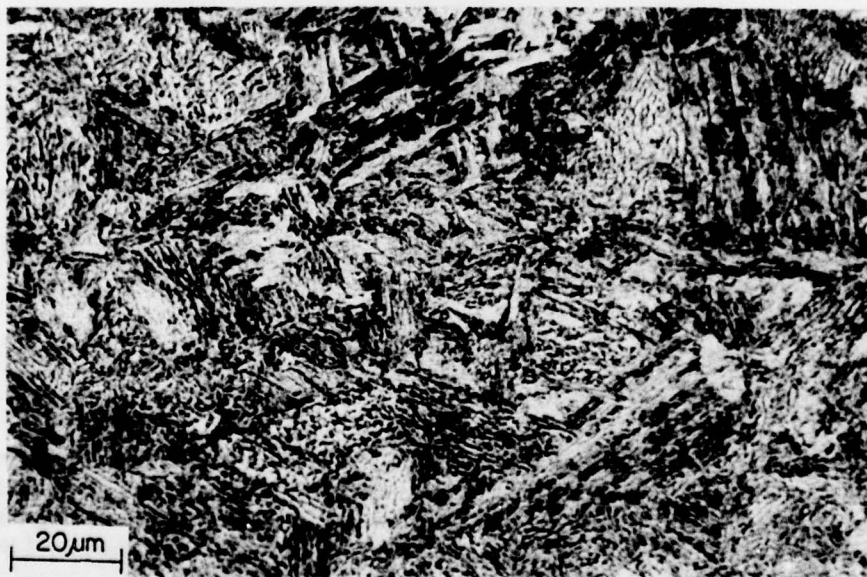
Fig. 59 — Code-F specimen: bainite at higher magnification than in Fig. 58
